Pine Canyon Lake Association

Lake Management Plan

September 22, 2022

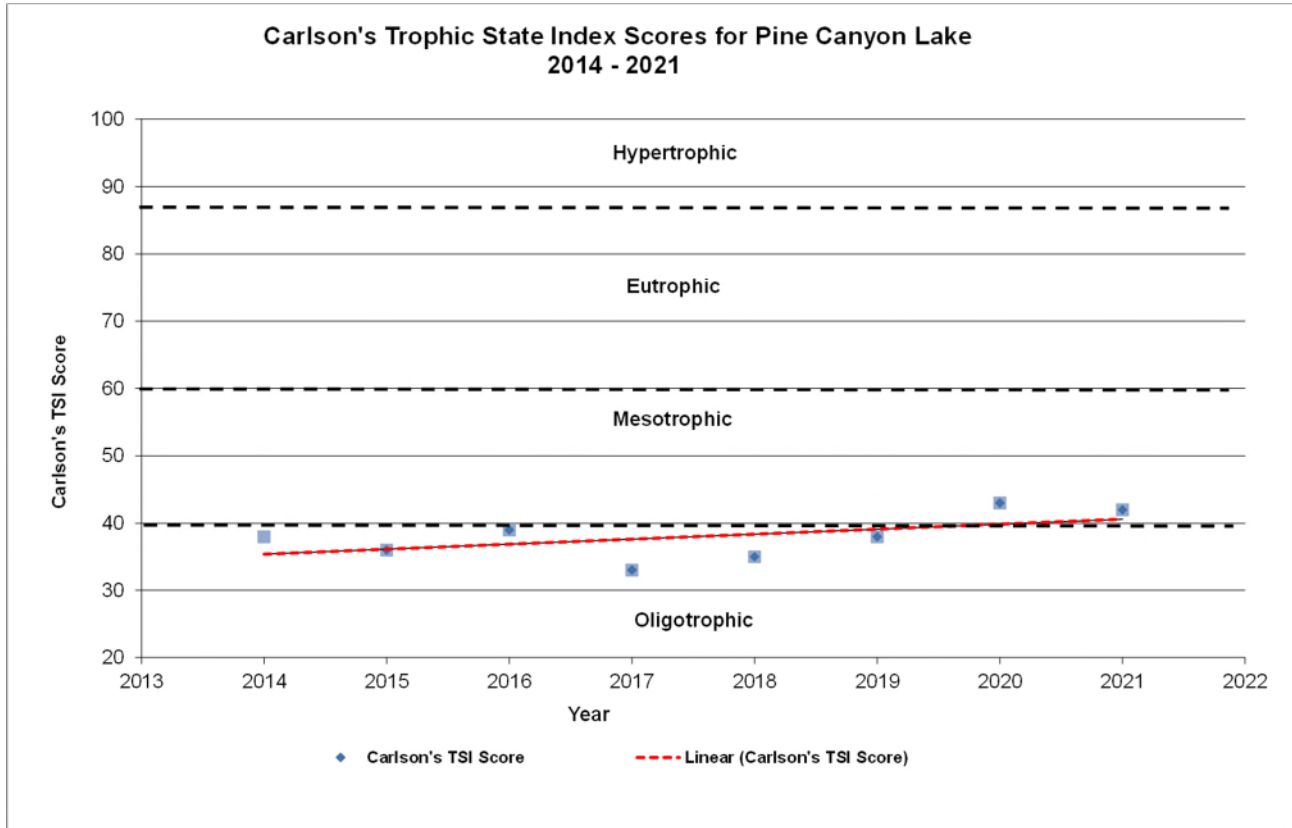
Figure 9: Carlson's Trophic State Index Scores 2014 - 2018

The 2021 score places the lake in the “mesotrophic” category, indicating the lake has experienced a moderate amount of nutrient enrichment. Lakes with this type of score generally support healthy ecosystems, moderately clear waters, and are user-friendly for most recreational purposes. The mean annual Carlson’s TSI scores produced in 2014 through 2021 respectively are 38, 36, 39, 33, 35, 38, 43, and 42. Because a score higher than 40 places a lake in the “mesotrophic” category, Pine Canyon Lake in 2020 and 2021 was slightly above the division between “oligotrophic” and “mesotrophic”.

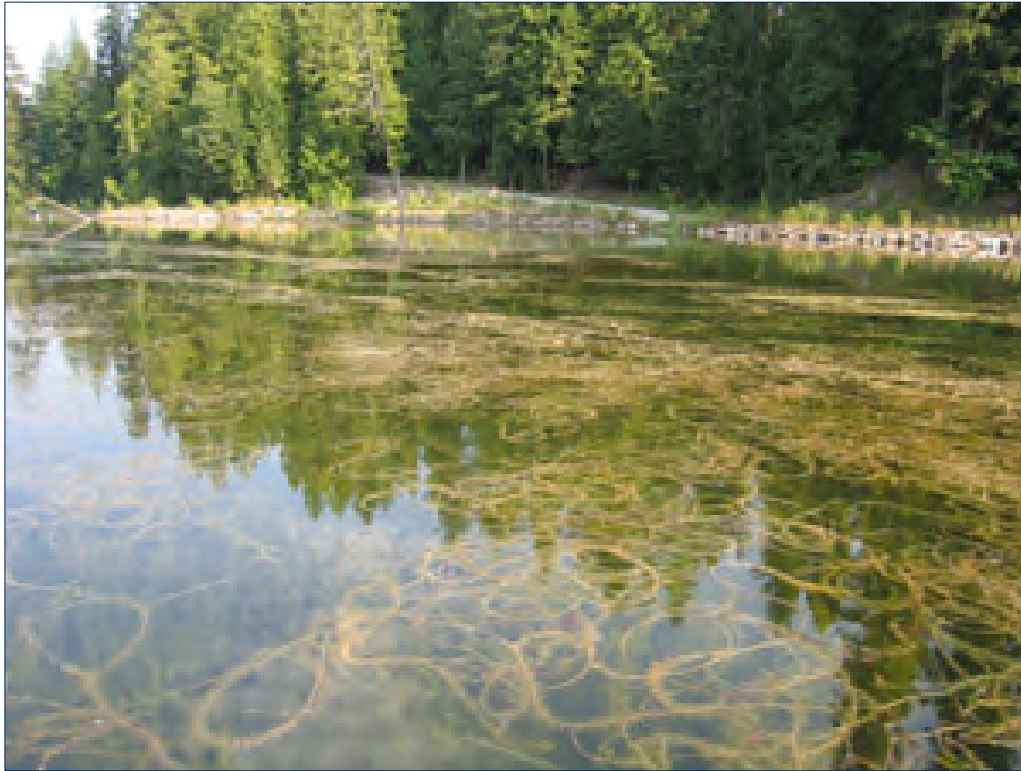
Watermilfoil produces long spaghetti-like stems that often grow up to the water's surface. Leaves are feather-like and resemble bones on a fish. 3-5 leaves are arranged in whorls around the stem, and each leaf contains 12-21 pairs of leaflets. At mid-summer small reddish flower spikes may emerge above the water's surface. Perhaps the most distinguishing characteristic, though, is the plant's ability to form dense, impenetrable beds that inhibit boating, swimming, and fishing.

However, because the Pine Canyon Lake community felt the 2,4-D treatments had produced undesirable side effects, no treatment for Watermilfoil has been applied since 2018. The result has been that Hybrid Watermilfoil colonization grew substantially and reached a severe nuisance level in 2021.

The hybridization between Eurasian Watermilfoil and Northern Watermilfoil in Pine Canyon Lake noted in Aquatic Enhancement's report exacerbates the problem. Hybrid Watermilfoil typically has thicker stems, is a prolific flowerer, and grows much faster than pure-strain Eurasian Watermilfoil. These attributes might contribute to this plant being less susceptible to chemical control strategies. An investigation of 28 whole-lake treatments in Wisconsin indicated smaller population reductions and shorter longevity of control on lakes that contained Hybrid Watermilfoil populations compared to lakes with only pure-strain Eurasian Watermilfoil.

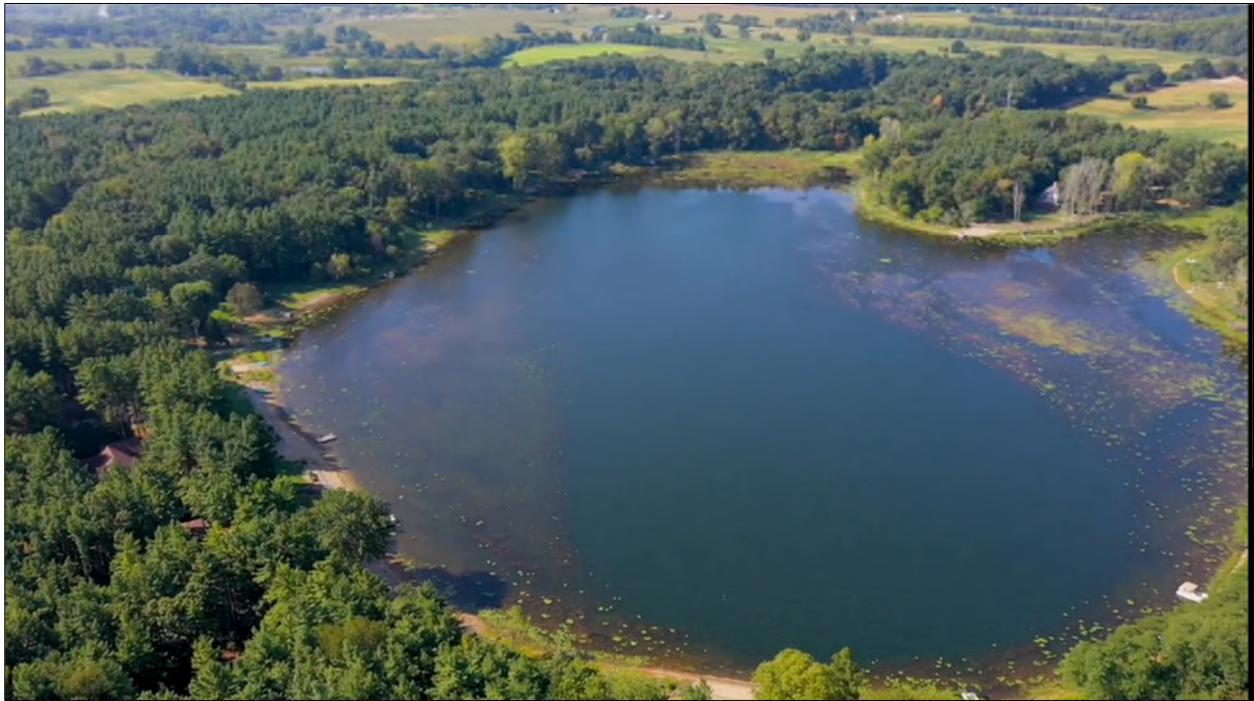
Pine Canyon Lake in October, 2021

During the summer of 2021, the Watermilfoil spread to infest large areas of the lake, as shown in this aerial photo taken in mid-October.

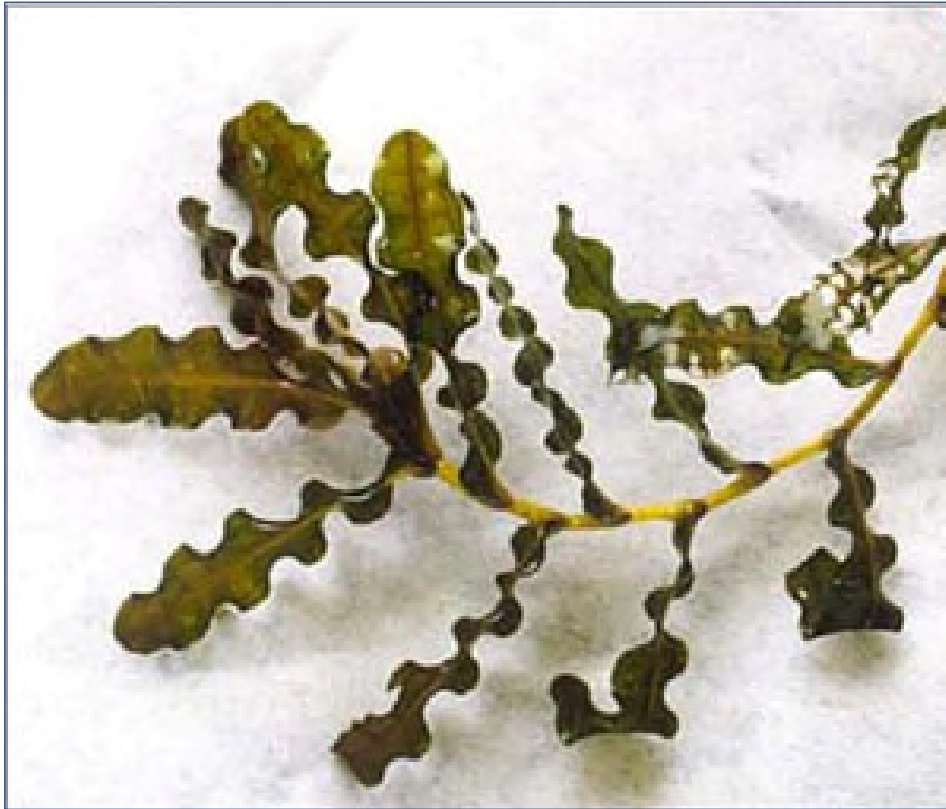
As stated previously, Aquatic Enhancement & Survey, Inc. reported in 2018 that curly-leaf pondweed plants were present in the lake. Then, on May 19, 2022, Aquatic Enhancement reported that they observed during their application of ProcellaCOR to treat the Watermilfoil "a significant amount of Curly-Leaf Pondweed growing the lake". However, the PCLA Board did not engage Aquatic Enhancement & Survey to treat the Curly-Leaf Pondweed in 2022.

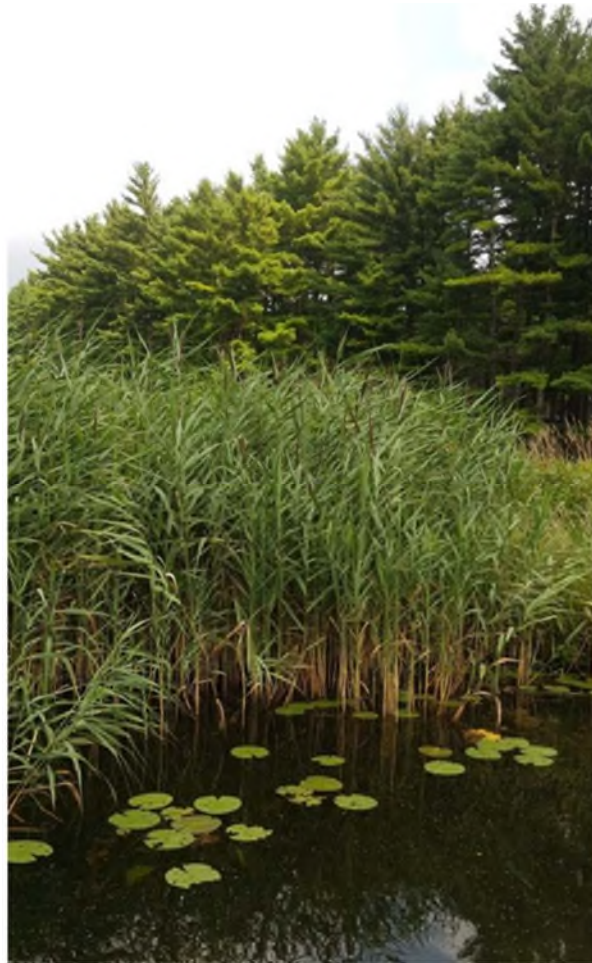
Phragmites at Pine Canyon Lake in September 2019

The only shoreline condition that has been a problem is infestation by a non-native invasive type of Phragmites (*phragmites australis*) also known as “giant reed grass” first noticed in 2019. This wetland plant could form a ring around the lake, displacing beneficial native wetland vegetation and decreasing the value of the lake’s wetland areas for wildlife, while impairing visual and recreational access for residents.

Lake-wide treatment of these plants using glyphosate was begun immediately in 2019. However, Phragmites have been observed growing on the shoreland in August 2022. Therefore, additional treatment is needed as soon as possible, and future ongoing monitoring and spot treatments will be necessary.

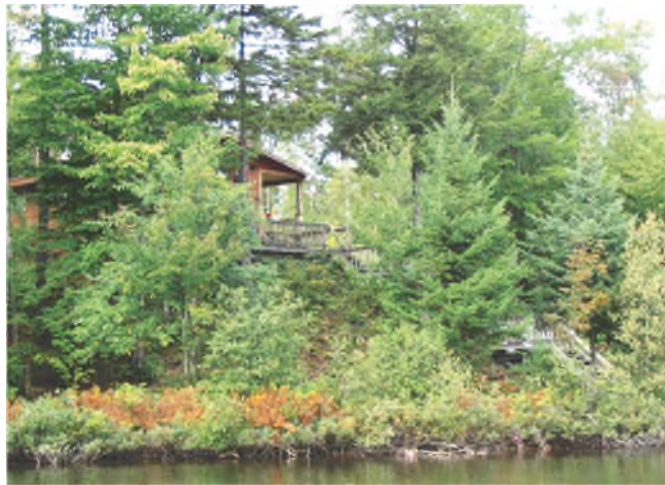
Some are like the picture below and would rate as having shoreland with a buffer greater than 50% of the lot width and an understory with greater than 50% natural cover.

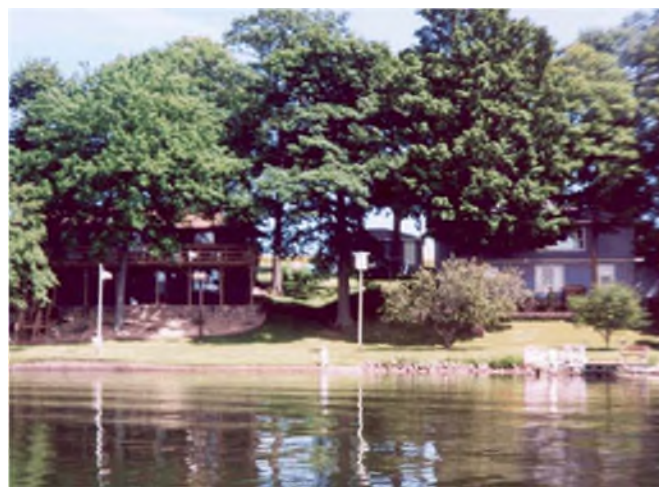
But others are like the picture below and do not have a natural shoreland buffer greater than 50% of the lot width. Also, the understory in the upland area would be rated as having less than 50% natural cover.
